# Uniform Mitigation Verification Inspection Form

| Inspection Date: <b>2/12/2025</b> | | | |
| Owner Name: <b>Chateau Deville of Tallahassee</b> | | Contact Person: <b>Mary Elizabeth Jackson</b> | |
| Address: <b>2020 Continental Avenue Bld. 1</b> | | Home Phone: | |

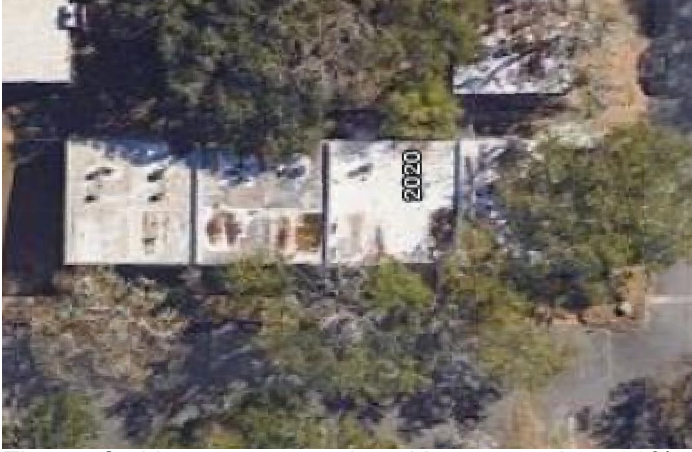
Flat roof with 5 or more units with greater than 90%  
flat roof  
5680 flat roof sq. ft. 5680 total sq. ft.

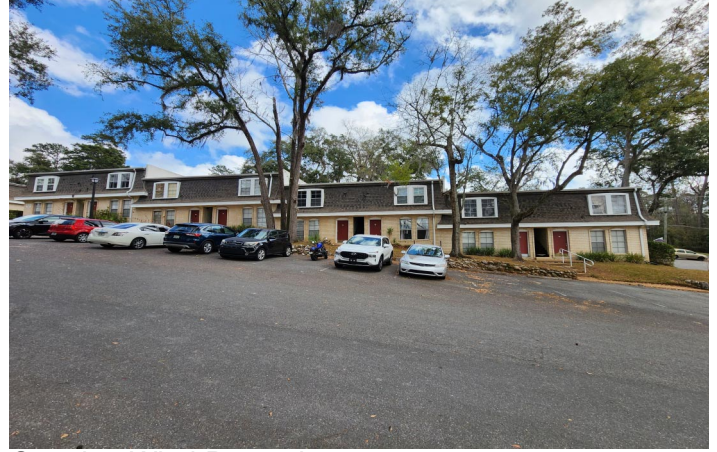
Opening Wind Protection:  
None on one or more openings
