# Uniform Mitigation Verification Inspection Form

| Address: <b>2020 Continental Avenue Bld. 12</b> | | Home Phone: | |

Wind Mitigation Report Prepared by:  
Austin Howard CMH Home Inspections, llc 850-567-2603  
Client: [Chateau Deville of Tallahassee](#)  
Property: [2020 Continental Avenue Bld. 12, Tallahassee, FL 32304](#)

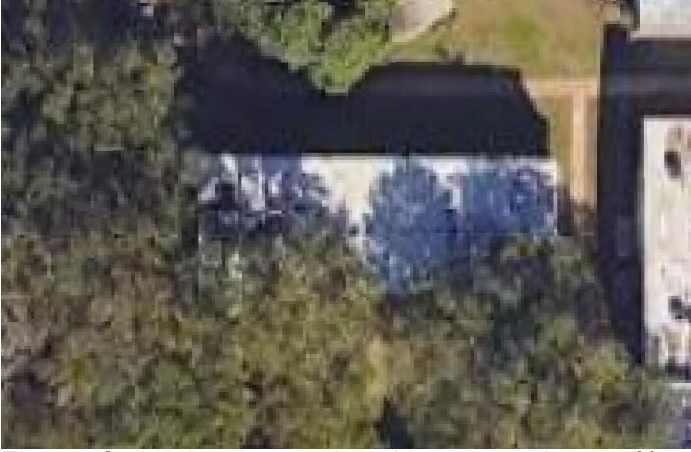
Flat roof with 4 or less units with greater than 90% flat roof

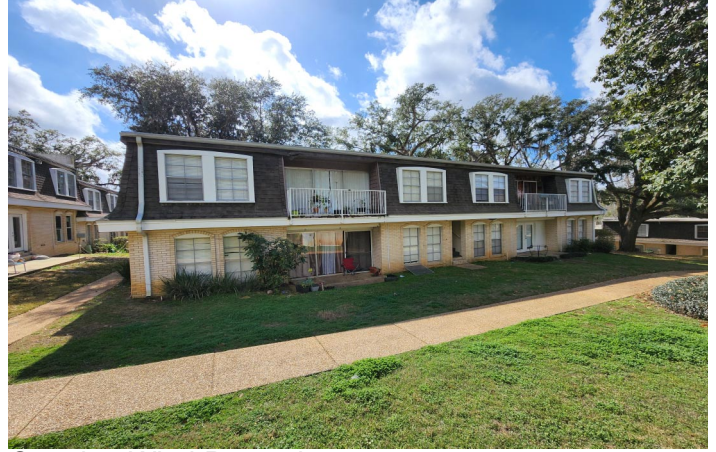
Opening Wind Protection:  
None on one or more openings

Roof Deck Attachment, Roof to Wall Attachment and SWR could not be determined. No attic access.
