# Uniform Mitigation Verification Inspection Form

| Address: <b>2020 Continental Avenue Bld. 3</b> | | Home Phone: | |

Wind Mitigation Report Prepared by:  
Austin Howard CMH Home Inspections, llc 850-567-2603

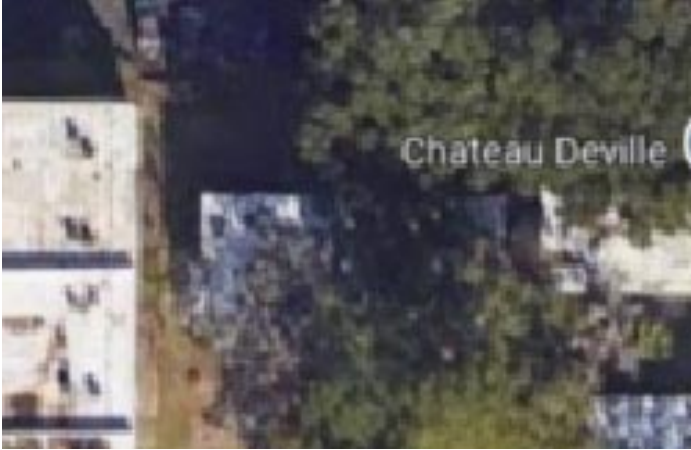
Flat roof with 4 or less units with greater than 90% flat roof

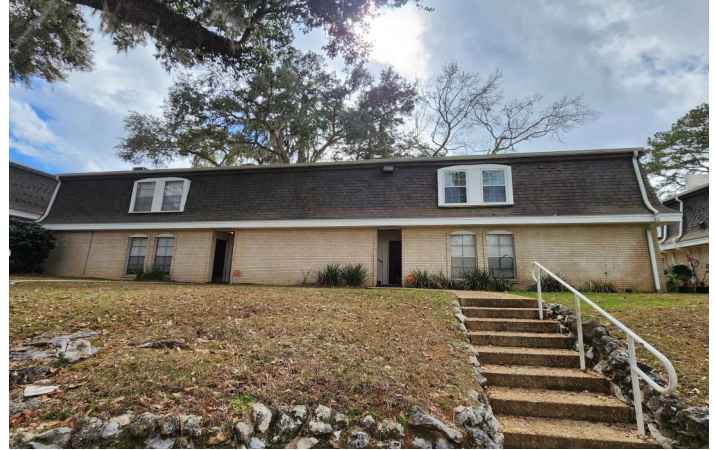
Opening Wind Protection:  
None on one or more openings

Roof Deck Attachment, Roof to Wall Attachment and SWR could not be determined. No attic access.
